Fire Testing of Exterior Vents

Indicative testing conducted in accordance with the test methodology described in ASTM E2886/E2886M, Standard Test Method for Evaluating the Ability of Exterior Vents to Resist the Entry of Embers and Direct Flame Impingement

6"×14" Exterior Eave Vent (VFS 614 FF)

WFCi Report #15021r1

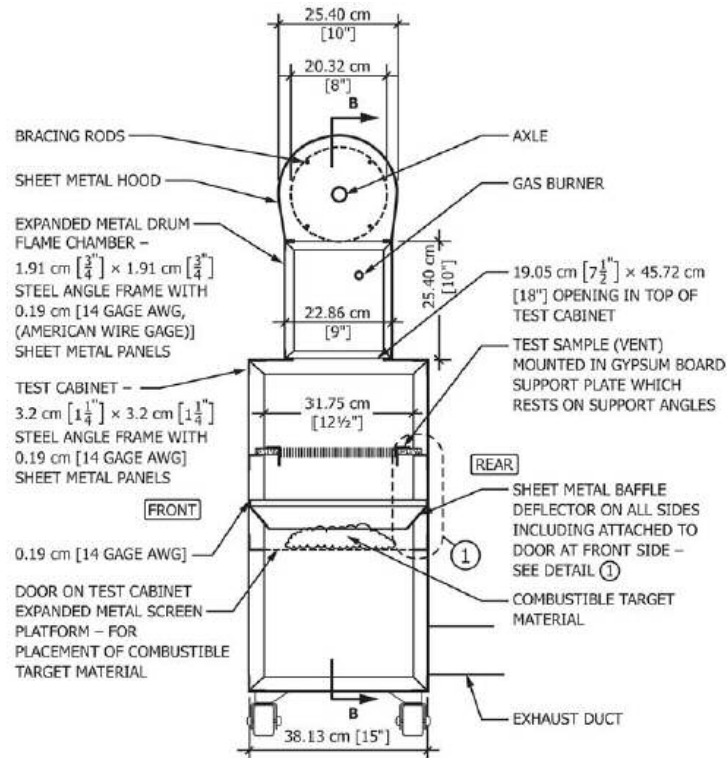
Figure 1. Ember test assembly showing tumbler, vent, and target locations.

Embers are generated from a circular tumbler filled with 10 Class C brand (ASTM E108) positioned over a representative installed horizontal exterior vent and combustible target material. The brands are ignited by a 2” gas flame for a 3 min period. After the brand ignition, the tumbler is activated allowing the created embers to fall on top of the vent (upper shelf). Embers that the vent does not collect/stop can pass through and ignite a combustible cotton target (lower shelf) below the vent. Air flow is regulated by a fan downstream of the tumbler, vent, and target material at a velocity of 2 mi/hr. The test is run until all the embers have run out of the tumbler and all combustion ceased. Assembly dimensions and locations are described in Figure 1 as well as the actual installation in Figure 2.

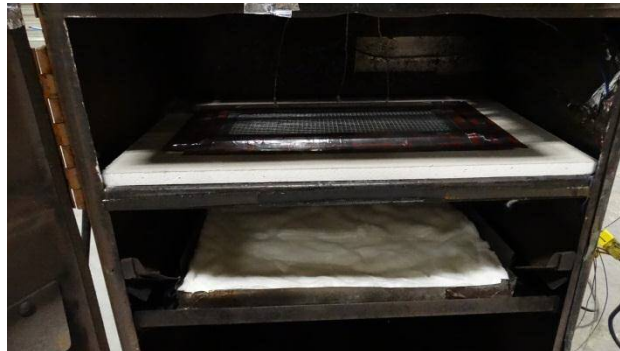
Figure 2. Actual installation of vent in ember chamber with upper and lower shelf.

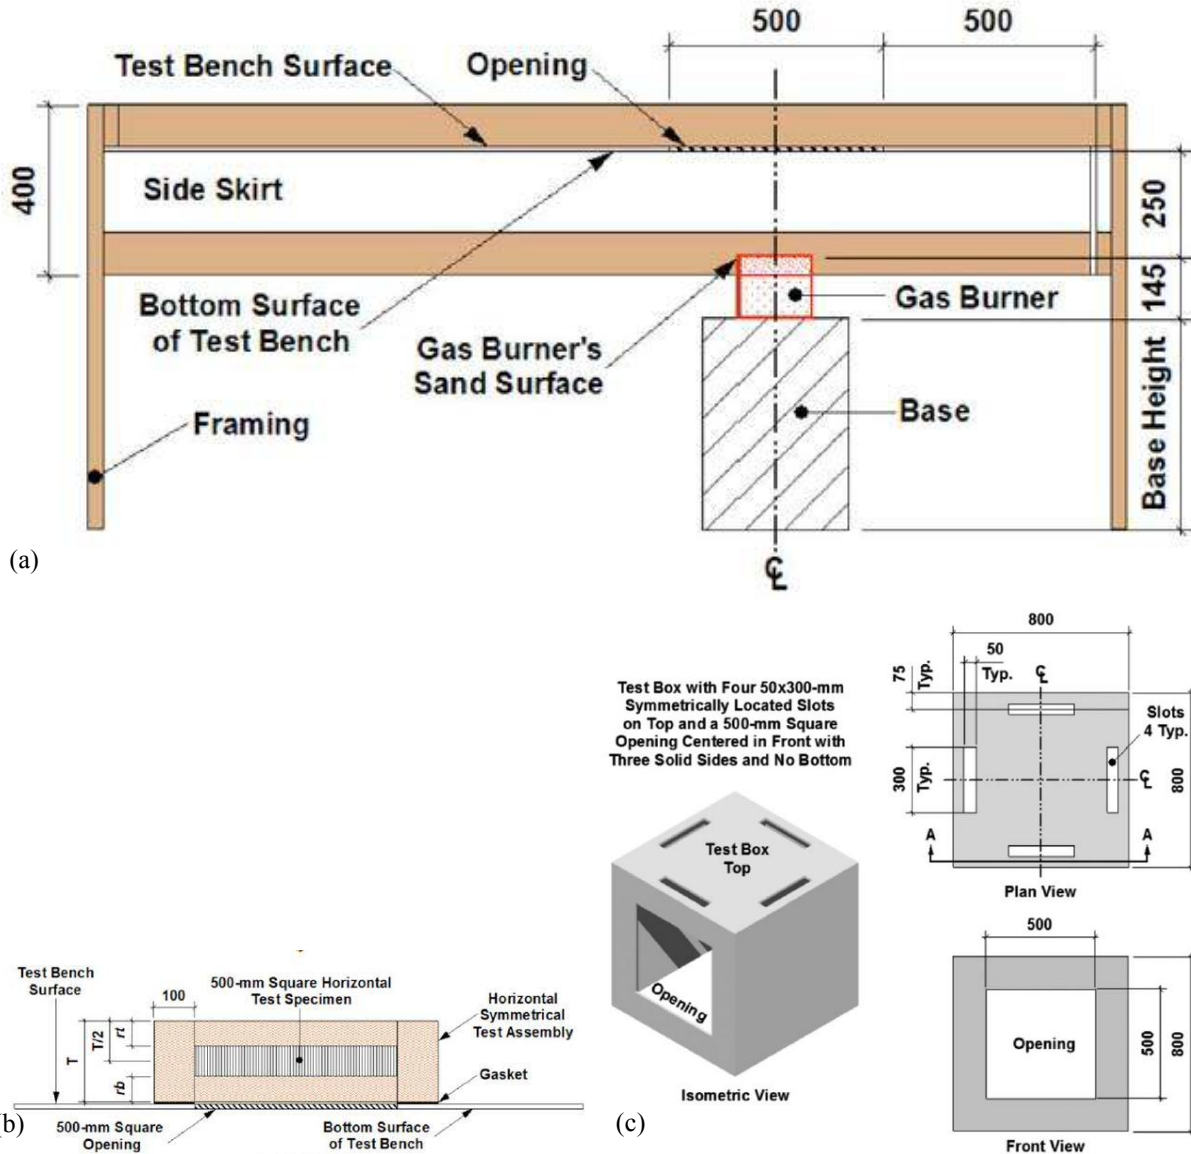
Figure 3. Direct flame apparatus showing (a) overall table, (b) horizontal lid and vent, and (c) box for vertical vents.

A nominal 4'×8' table (Figure 3) was used for the direct flame exposure. The table had a 20"×20" hole cut on one side and a 16" skirt on each side except the side away from the hole. A 6³/₄"×6³/₄" sand burner was positioned 10" below the table hole. A vent sample is installed in either a horizontal or vertical configuration. For the horizontal vent (Figure 3b), a 27¹/₂"×27¹/₂" flat lid with the installed vent was used to cover the table hole. For the vertical vent (Figure 3c), a 31¹/₂"×31¹/₂"×31¹/₂" box with the installed vent on one side was used to cover the table hole. The box had four 2"×12" holes in the top to allow flames to escape. Only the horizontal configuration will be addressed in this test report.

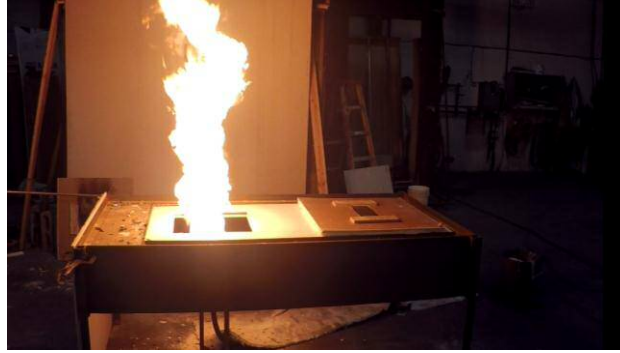
Figure 4. Actual flame prior to horizontal vent test.

Prior to the test, the gas flame was verified to have a heat output of 300 kW. The flat lid or box, depending on vent orientation, was slid over the table hole. The test is designed to run for 10 min. At 30 s, 5 m, and 9 m 30 s into the test, a target cotton pad was placed next to the vent for

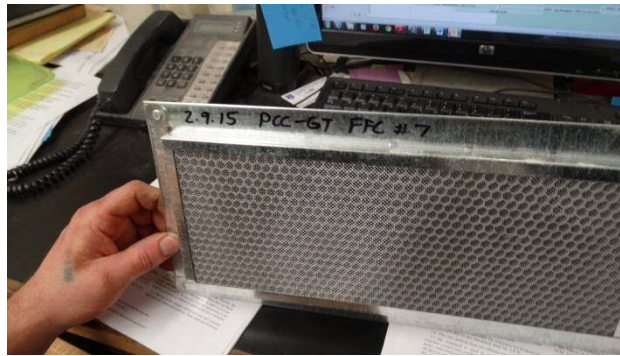
Figure 5. Vent identification.

A nominal 6"×14" (7"×15" with flange, 5½"×13½" without flange) representative exterior eave vent (VFS 614 FF) produced by Vulcan Technologies, Inc was used as the test sample for all tests. The vent is a protected/coated honeycomb panel encased in metal framework. Each vent was third-part witnessed by Product Certification Consultants, LLC (APPENDIX A: INSPECTION REPORT) and identified as '2-9-15 PCC-GT, FFC, #1 through #12' (Figure 5). Each vent was weighed prior to testing. WFCi did not select the sample components and has not verified the manufacturing techniques or accuracy of the products and labeling.

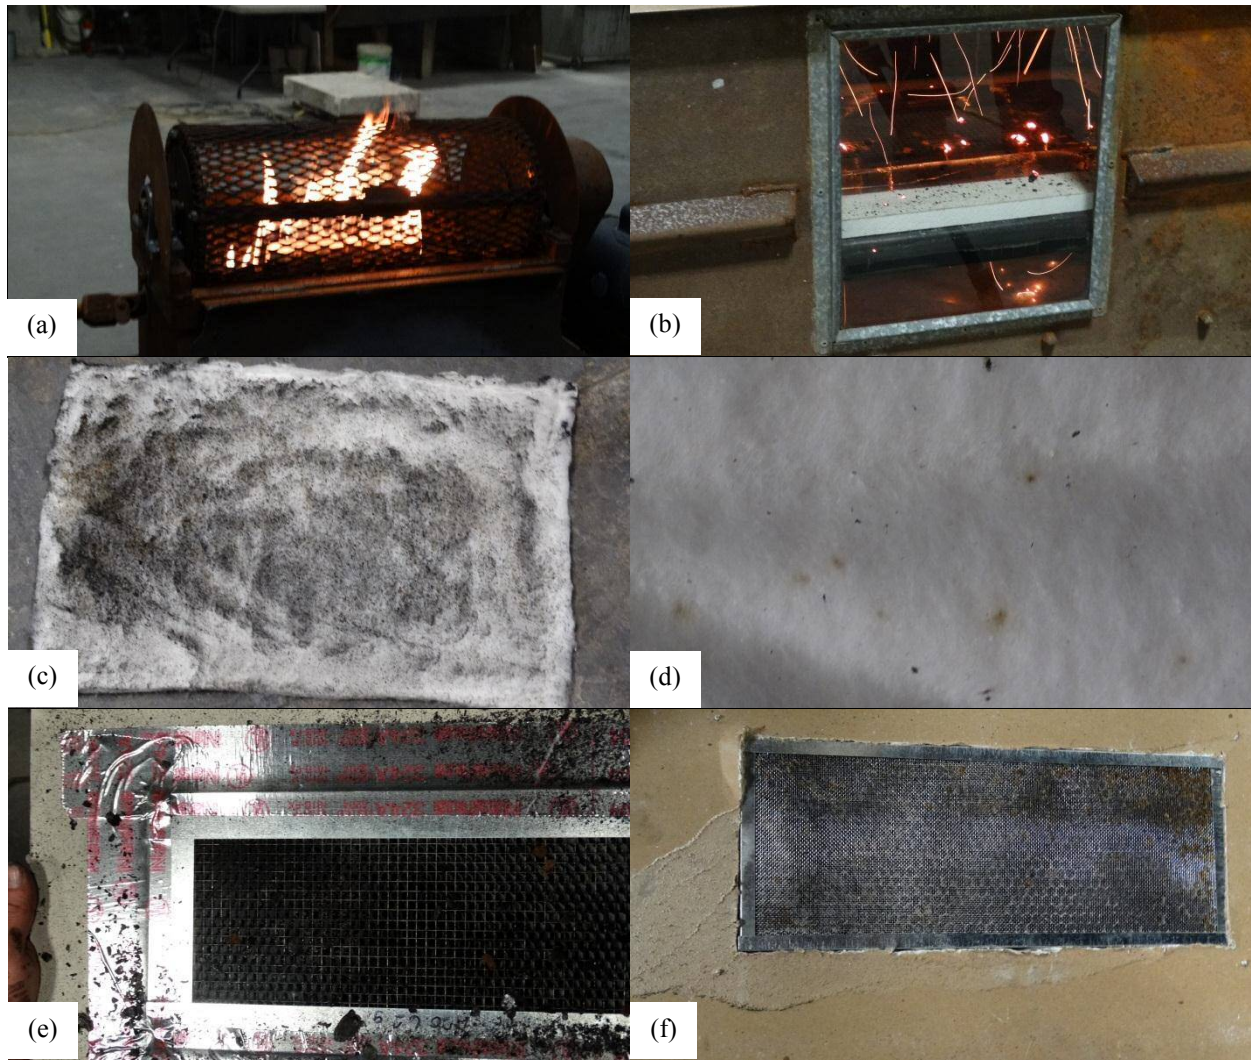
Figure 6. Test 1 showing (a) flaming brands, (b) embers through vent, (c) cotton front, (d) cotton back, (e) vent front, and (f) vent back.

Test Time (mm:ss)	Event
-03:30	Burner applied to brands (15 s delay in flame adjustment)
-00:15	Gas off – shield/door being closed
00:00	Start test – tumbler activated
00:20	Small embers through vent – charring cotton
05:40	Reduced embers
10:10	All combustion out – terminate test

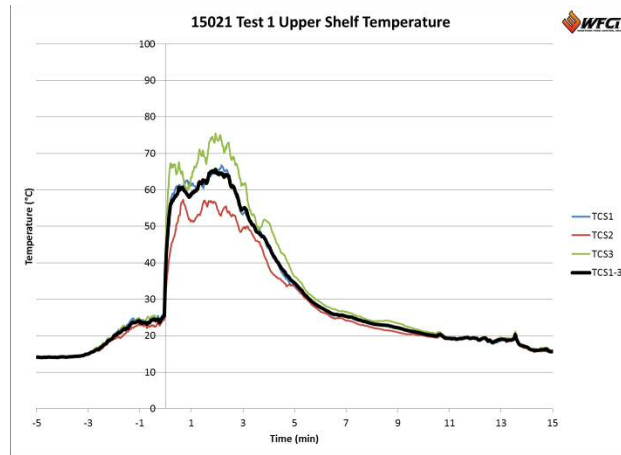
Figure 7. Test 1 temperature just above vent.

The three thermocouples (Figure 7) just above the vent on the upper shelf showed an initial spike to around 60°C when the tumbler was activated which remained for approximately 3 min, then gradually decreased as the embers burned out.

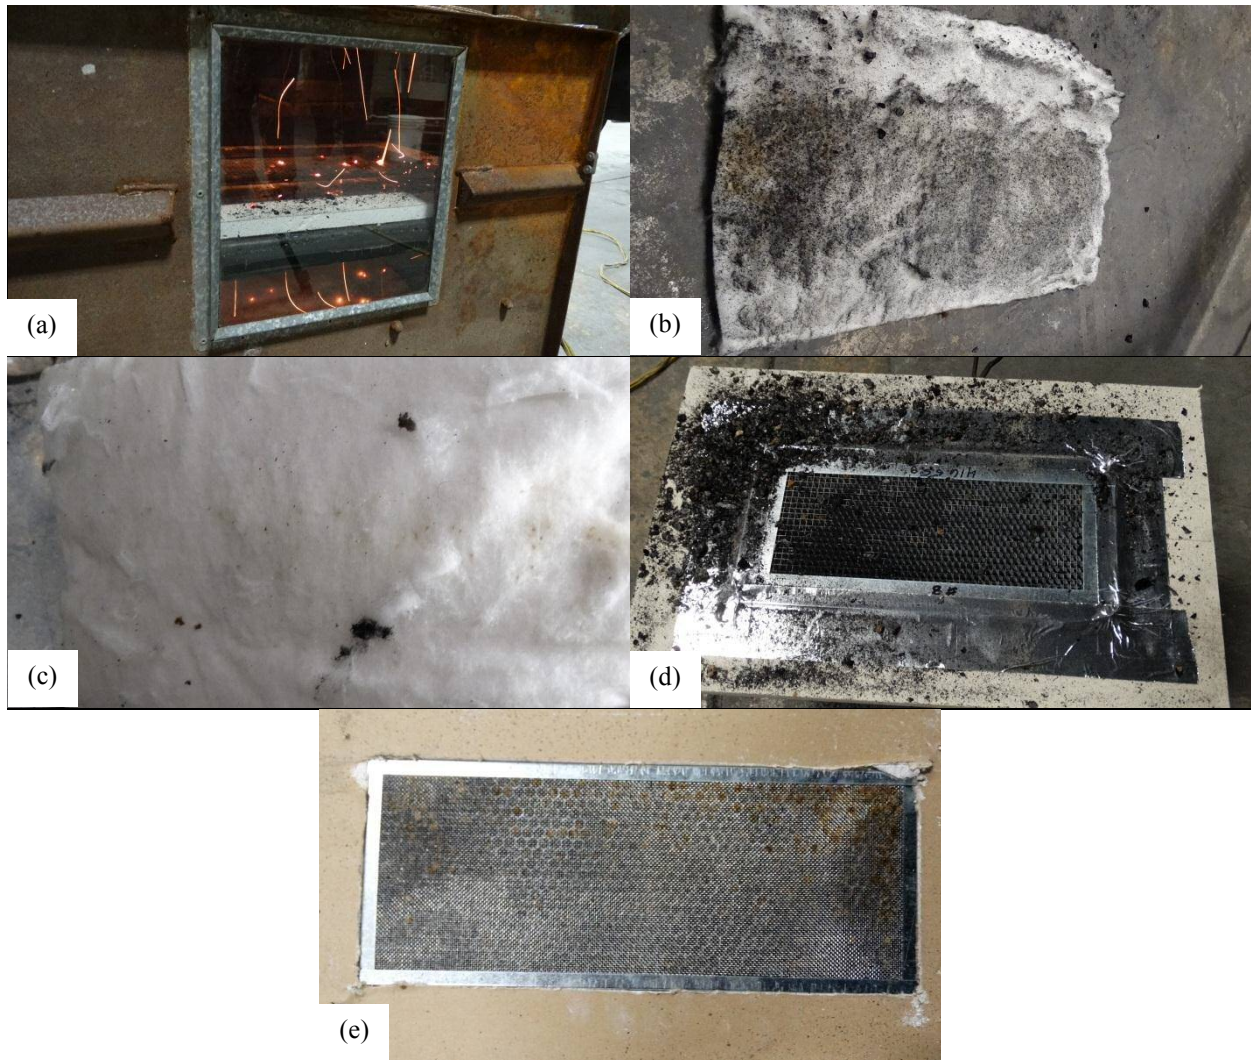
Figure 8. Test 2 showing (a) embers through vent, (b) cotton front, (c) cotton back, (d) vent front, and (e) vent back.

Test Time (mm:ss)	Event
-03:15	Burner applied to brands
-00:15	Gas off – shield/door being closed
00:00	Start test – tumbler activated – embers through vent
01:05	Charring cotton target
05:30	Reduced embers
10:00	All combustion out – terminate test

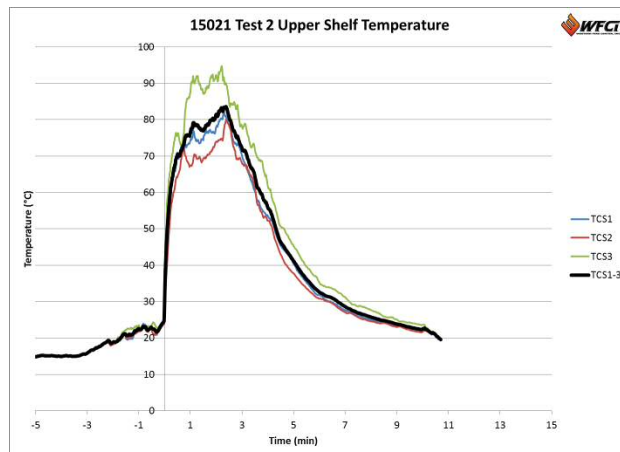
Figure 9. Test 2 temperature just above vent.

The three thermocouples (Figure 9) just above the vent on the upper shelf showed an initial spike to around 80°C when the tumbler was activated which remained for approximately 3 min, then gradually decreased as the embers burned out.

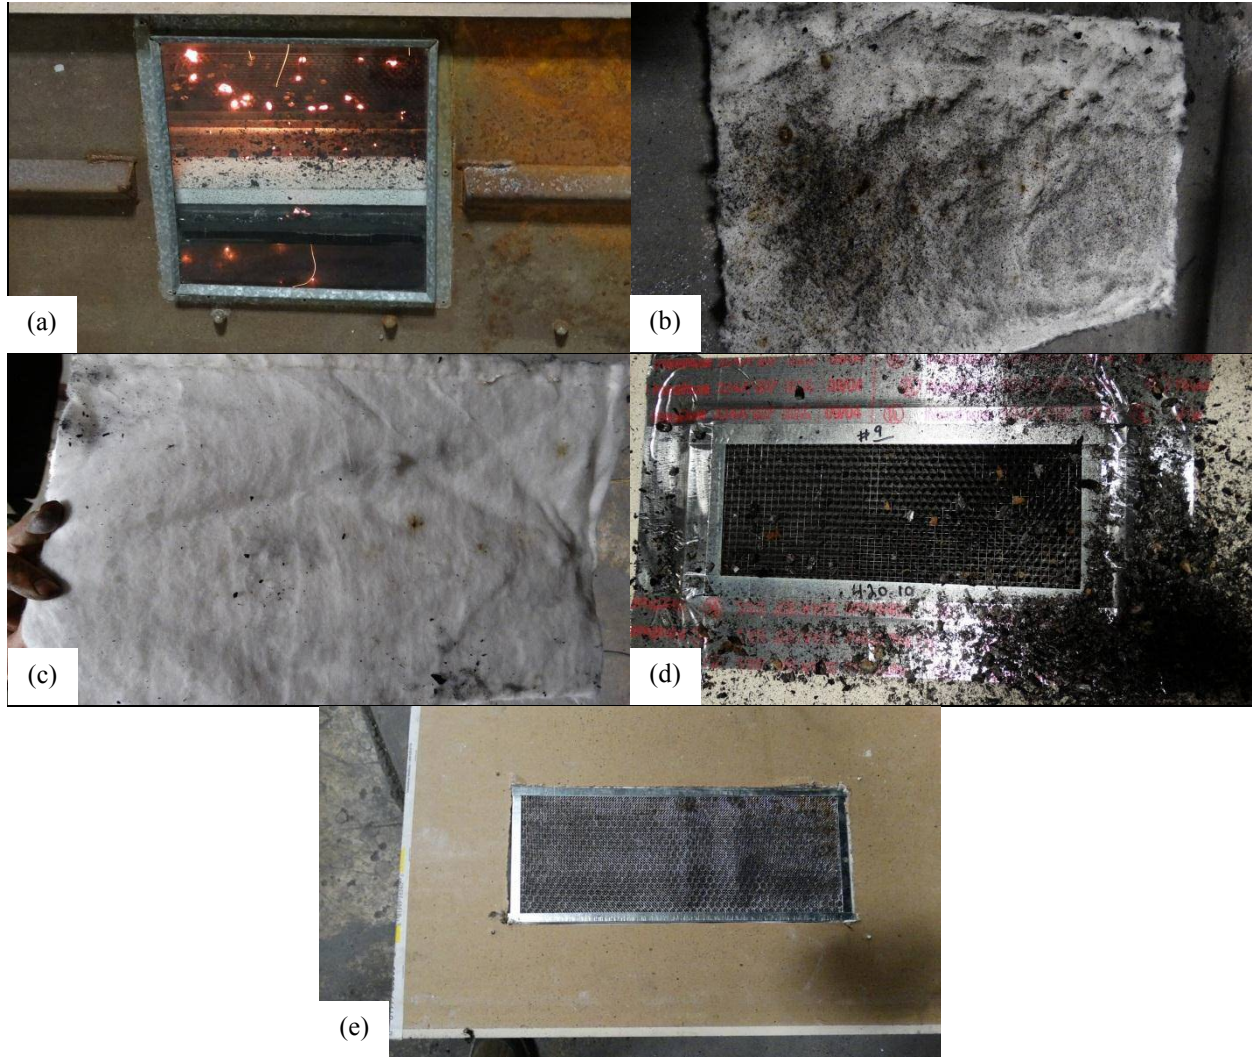
Figure 10. Test 3 showing (a) embers through vent, (b) cotton front, (c) cotton back, (d) vent front, and (e) vent back.

Test Time (mm:ss)	Event
-03:10	Burner applied to brands
-00:10	Gas off – shield/door being closed
00:00	Start test – tumbler activated
00:10	Ember through vent
01:55	Charring cotton target
06:15	Reduced embers
07:45	No visible embers in tumbler
10:00	All combustion out – terminate test

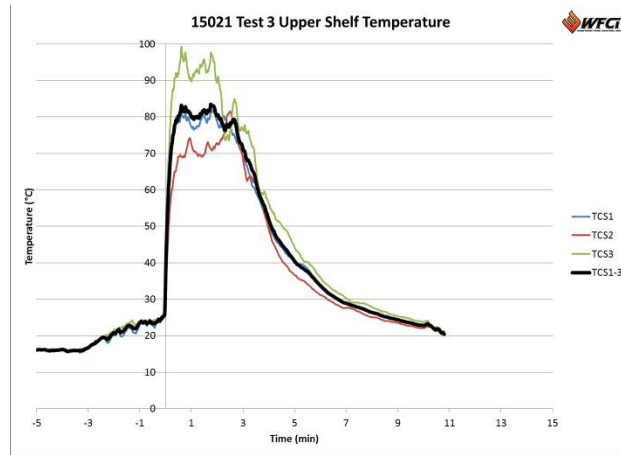
Figure 11. Test 3 temperature just above vent.

The three thermocouples (Figure 11) just above the vent on the upper shelf showed an initial spike to around 80°C when the tumbler was activated which remained for approximately 3 min, then gradually decreased as the embers burned out.

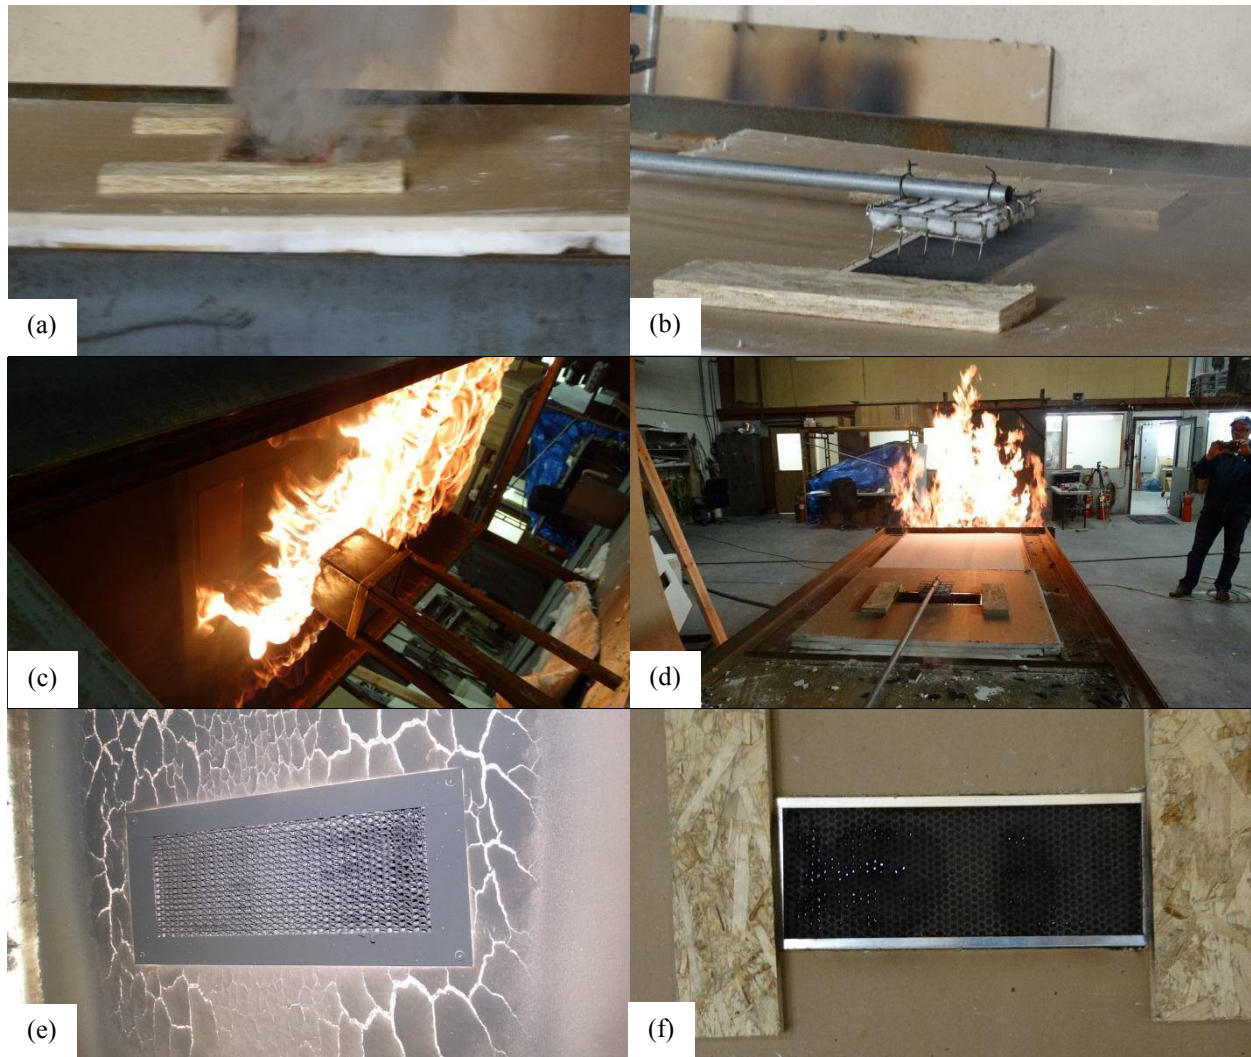
Figure 12. Test 5 showing (a) smoke through vent, (b) cotton 1, (c) flames under table, (d) flames out back end, (e) vent front, and (f) vent back.

Test Time (mm:ss)	Event
00:00	Start test – vent/lid moved over burner
00:30	Cotton target 1 on vent
01:00	Cotton target 1 off vent – no ignition, no discoloration
02:20	Pulsating flames out back end between 2’ and 6’ high
05:00	Cotton target 2 on vent
05:30	Cotton target 2 off vent – no ignition, no discoloration
09:30	Cotton target 3 on vent
10:00	Cotton target 3 off vent – no ignition, no discoloration – terminate test

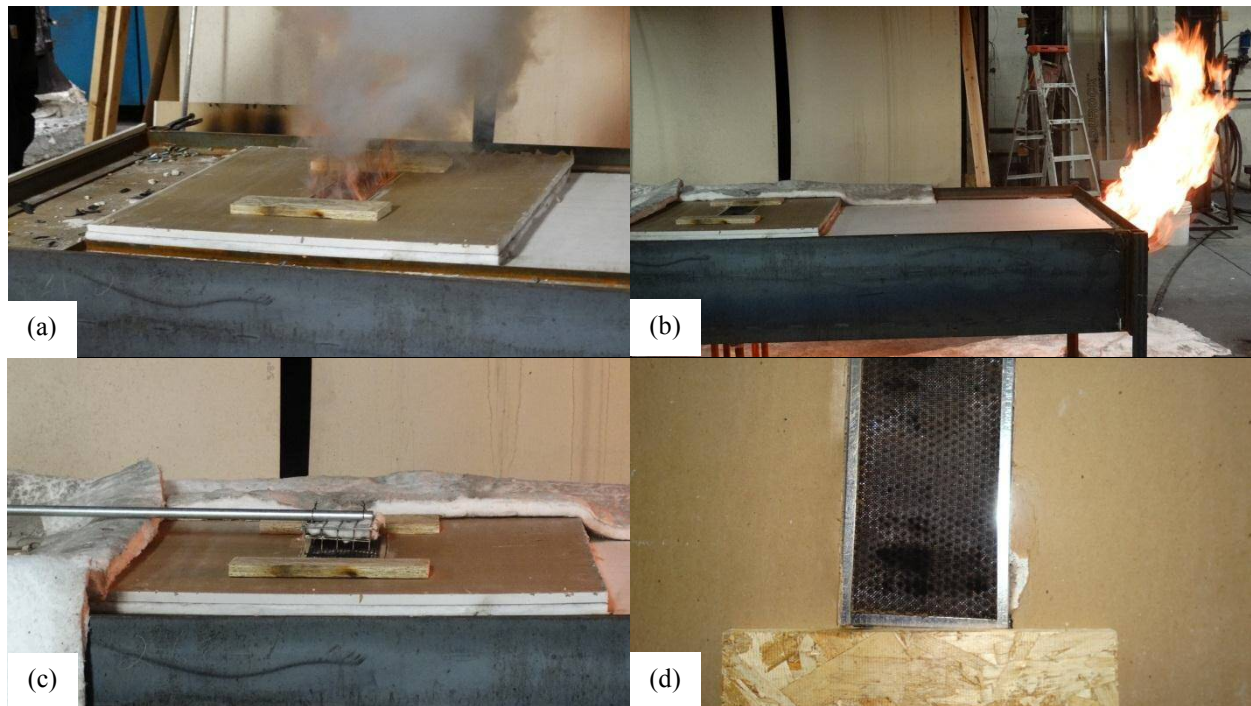
Figure 13. Test 6 showing (a) smoke through vent, (b) flames out back end, (c) cotton 3, (d) vent back.

Test Time (mm:ss)	Event
00:00	Start test – vent/lid moved over burner
00:30	Cotton target 1 on vent – flames around perimeter skirt
01:00	Cotton target 1 off vent – no ignition, no discoloration
05:00	Cotton target 2 on vent
05:30	Cotton target 2 off vent – no ignition, no discoloration

09:30	Cotton target 3 on vent
10:00	Cotton target 3 off vent – no ignition, no discoloration – terminate test

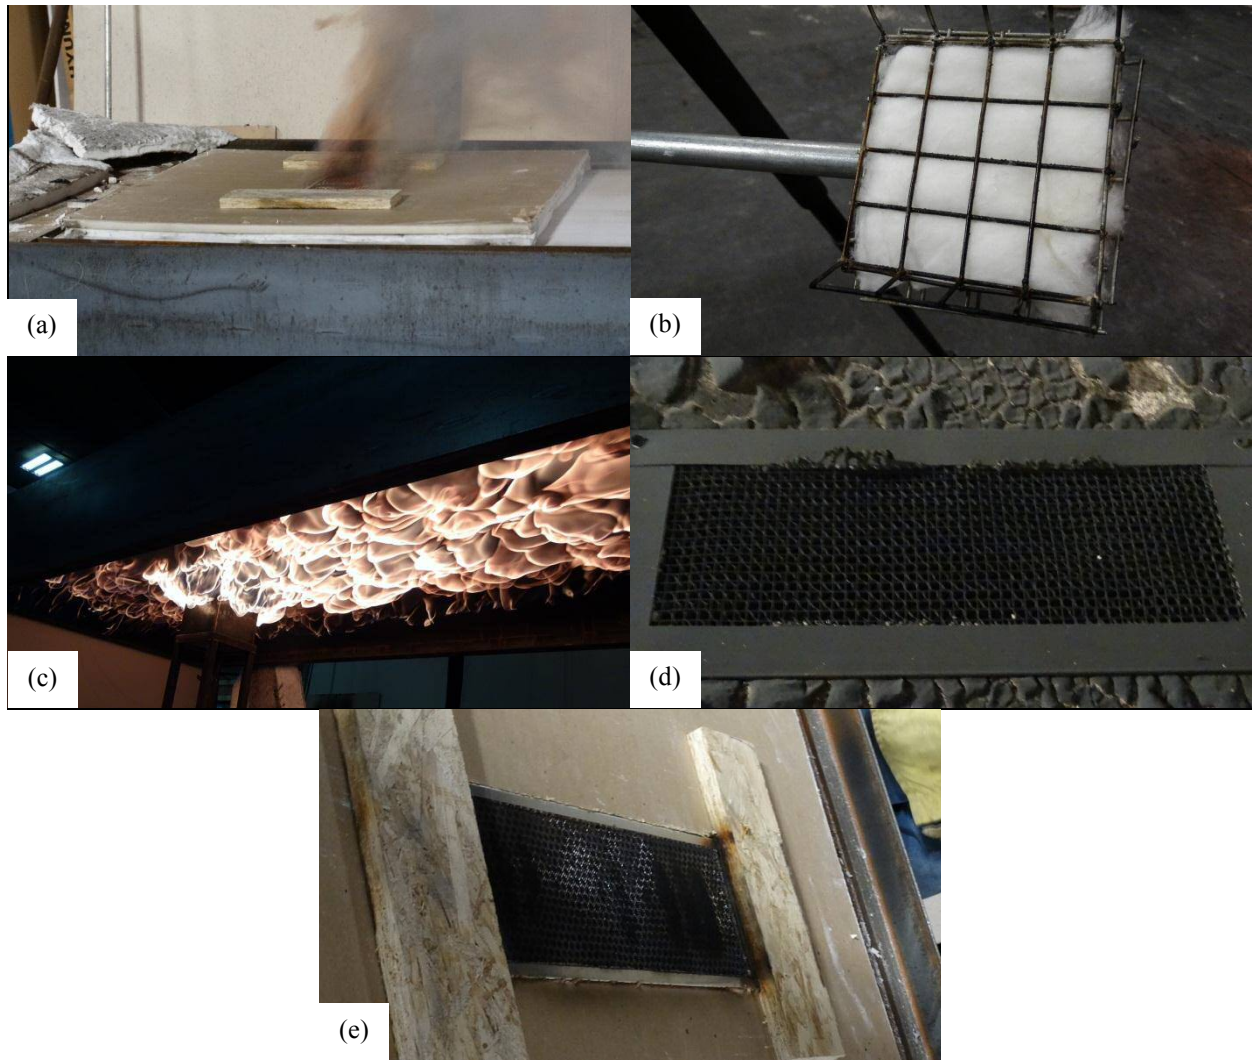
Figure 14. Test 7 showing (a) smoke through vent, (b) cotton 1 after exposure, (c) under table, (d) vent front, and (e) vent back.

Test Time (mm:ss)	Event
00:00	Start test – vent/lid moved over burner
00:30	Cotton target 1 on vent
01:00	Cotton target 1 off vent – no ignition, no discoloration
05:00	Cotton target 2 on vent
05:30	Cotton target 2 off vent – no ignition, no discoloration
09:30	Cotton target 3 on vent
10:00	Cotton target 3 off vent – no ignition, no discoloration – terminate test

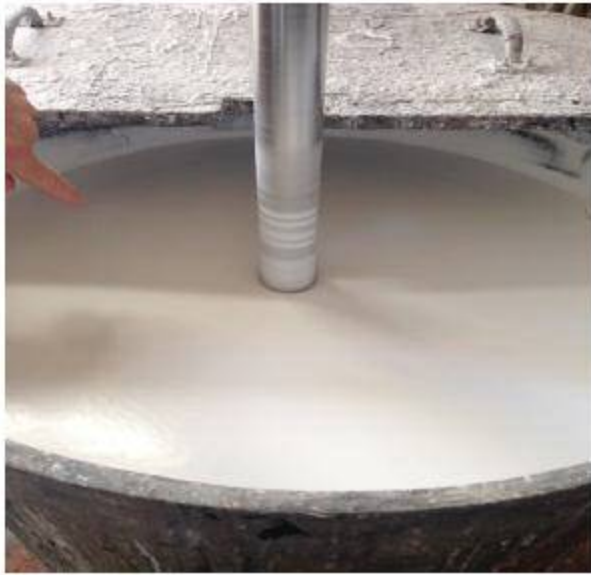
Photo 1—FF 88 Coating Mixing (1.28.15)

Proprietary coating is designated Firefree 88 (FF 88) and is a mix of liquid and powder components. The production ticket formulation is on file with the inspection agency. After mixing, the coating rests overnight. FF 88 is also listed with Factory Mutual (FM) and is under third party inspection.

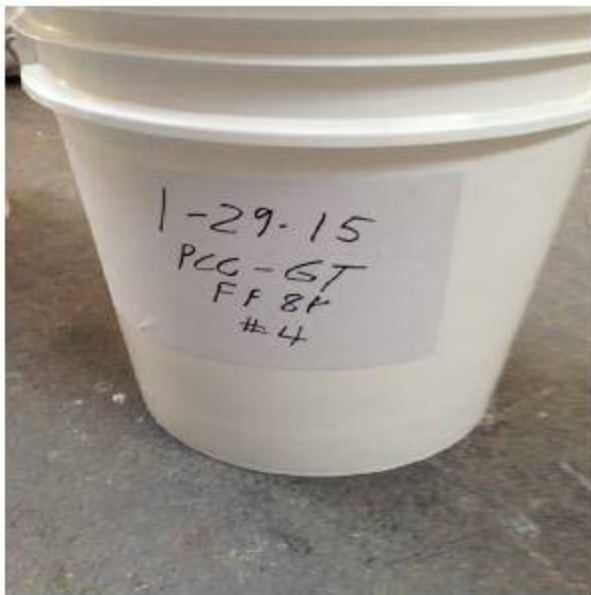
Photo 2—Coating Bucket ID (1.29.15)

Thirteen (13) buckets were identified with the following information.
1-29-15, PCC-GT, FF88, #1 thru #13

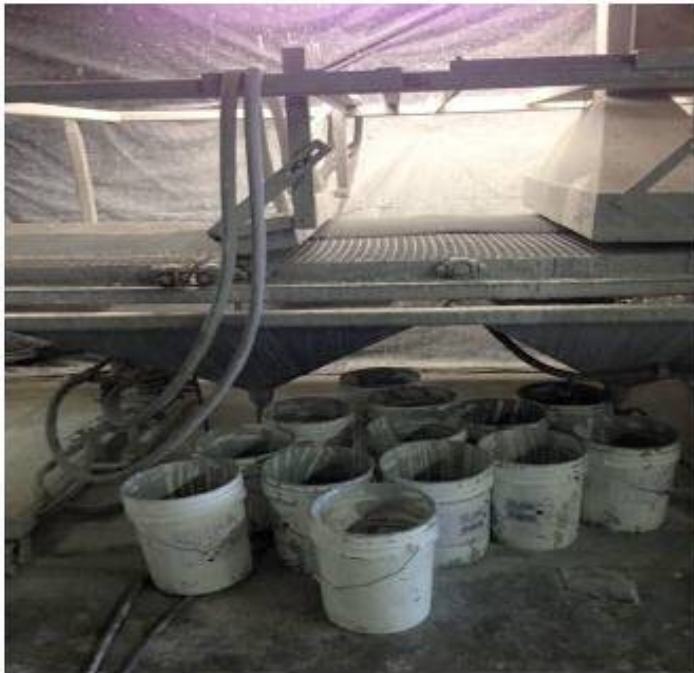
Photo 3—Coating Loading into Spray Equipment (2-3-15)

The marked buckets were confirmed and the contents were poured into the coating equipment where the coating of the aluminum honeycomb core, nominal 5/8" thick with 1/4" cells with 1-2 mil cell walls. The core sheets need to be dried prior to cutting to size and final assembly.

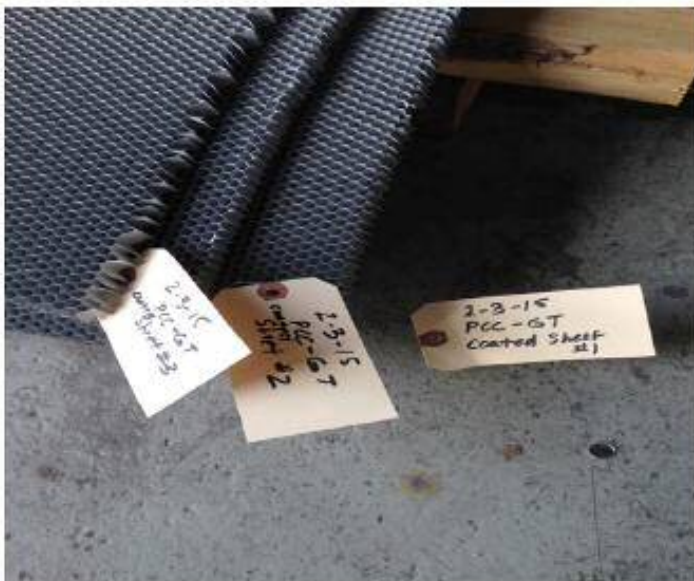
Photo 4—Core Coated Sheets ID (2-3-15)

Three (3) core sheets were identified with the following information.
2-3-15, PCC-GT, Coated Sheet #1, #2, #3

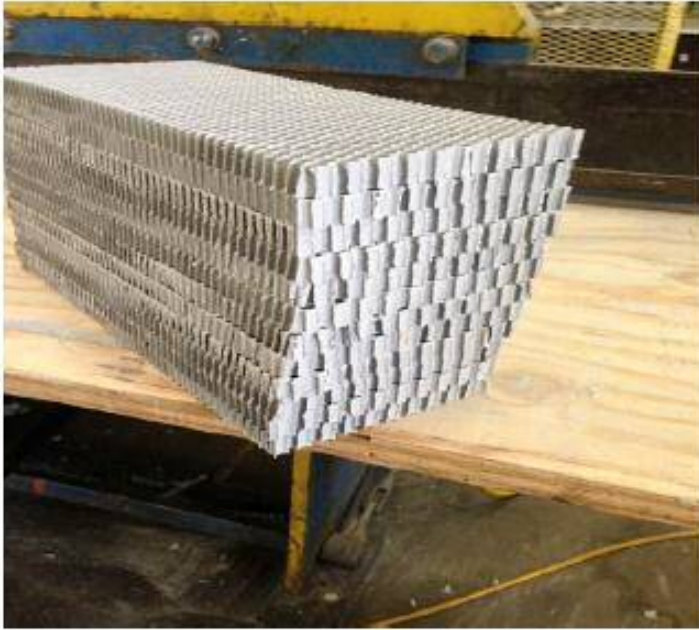
Photo 5—Cores Cut to Size (2-9-15)

Coated sheet #3 was cut to size (5-1/4" x 13-1/4") and assembled into the four (4)-- 28 gauge galvanized steel frame components. Core protected with 1/4" hardware cloth on one side and a 16 mesh fine screen on the other.

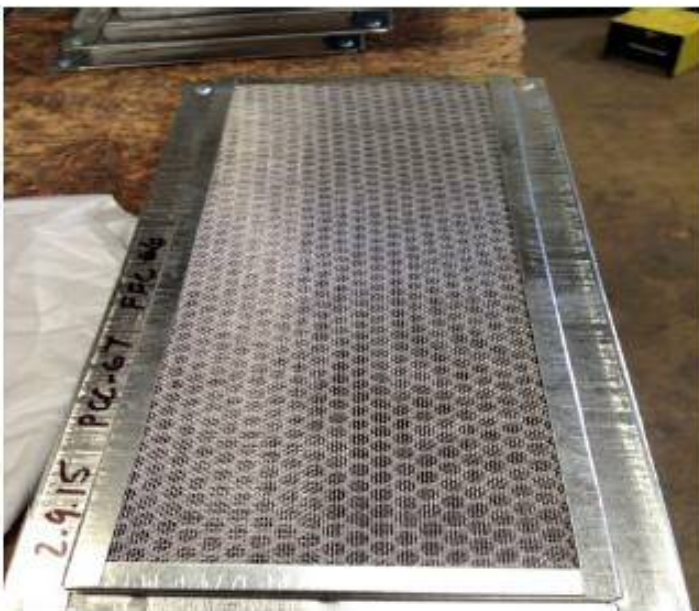
Photo 6—Finished Exterior Eave Product (2-9-15)

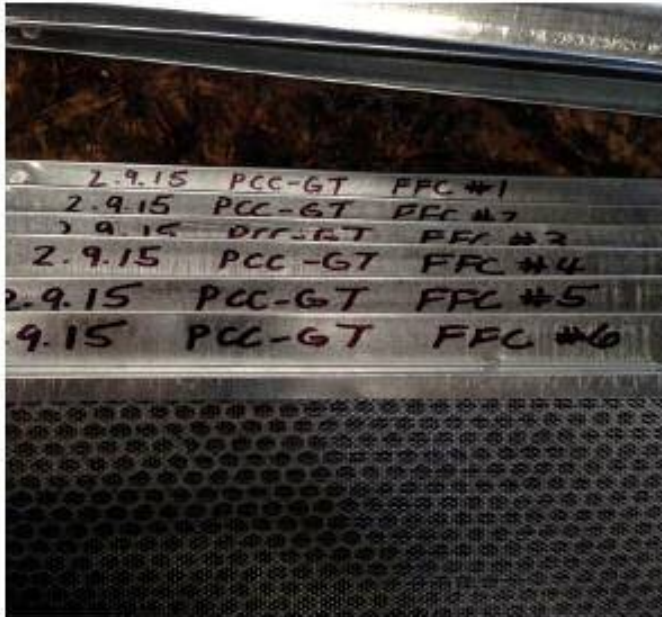
Photo 7—Finished Exterior Eave ID #1-#6 (2-9-15)

Twelve (12) finished "Exterior Eave" were identified with the following information.
2-9-15, PCC-GT, FFC, #1 thru #12
